The Martian Landscape

By The Viking Lander Imaging Team

Scientific and Technical Information Office
NATIONAL AERONAUTICS AND SPACE ADMINISTRATION
Washington, D.C. 1978

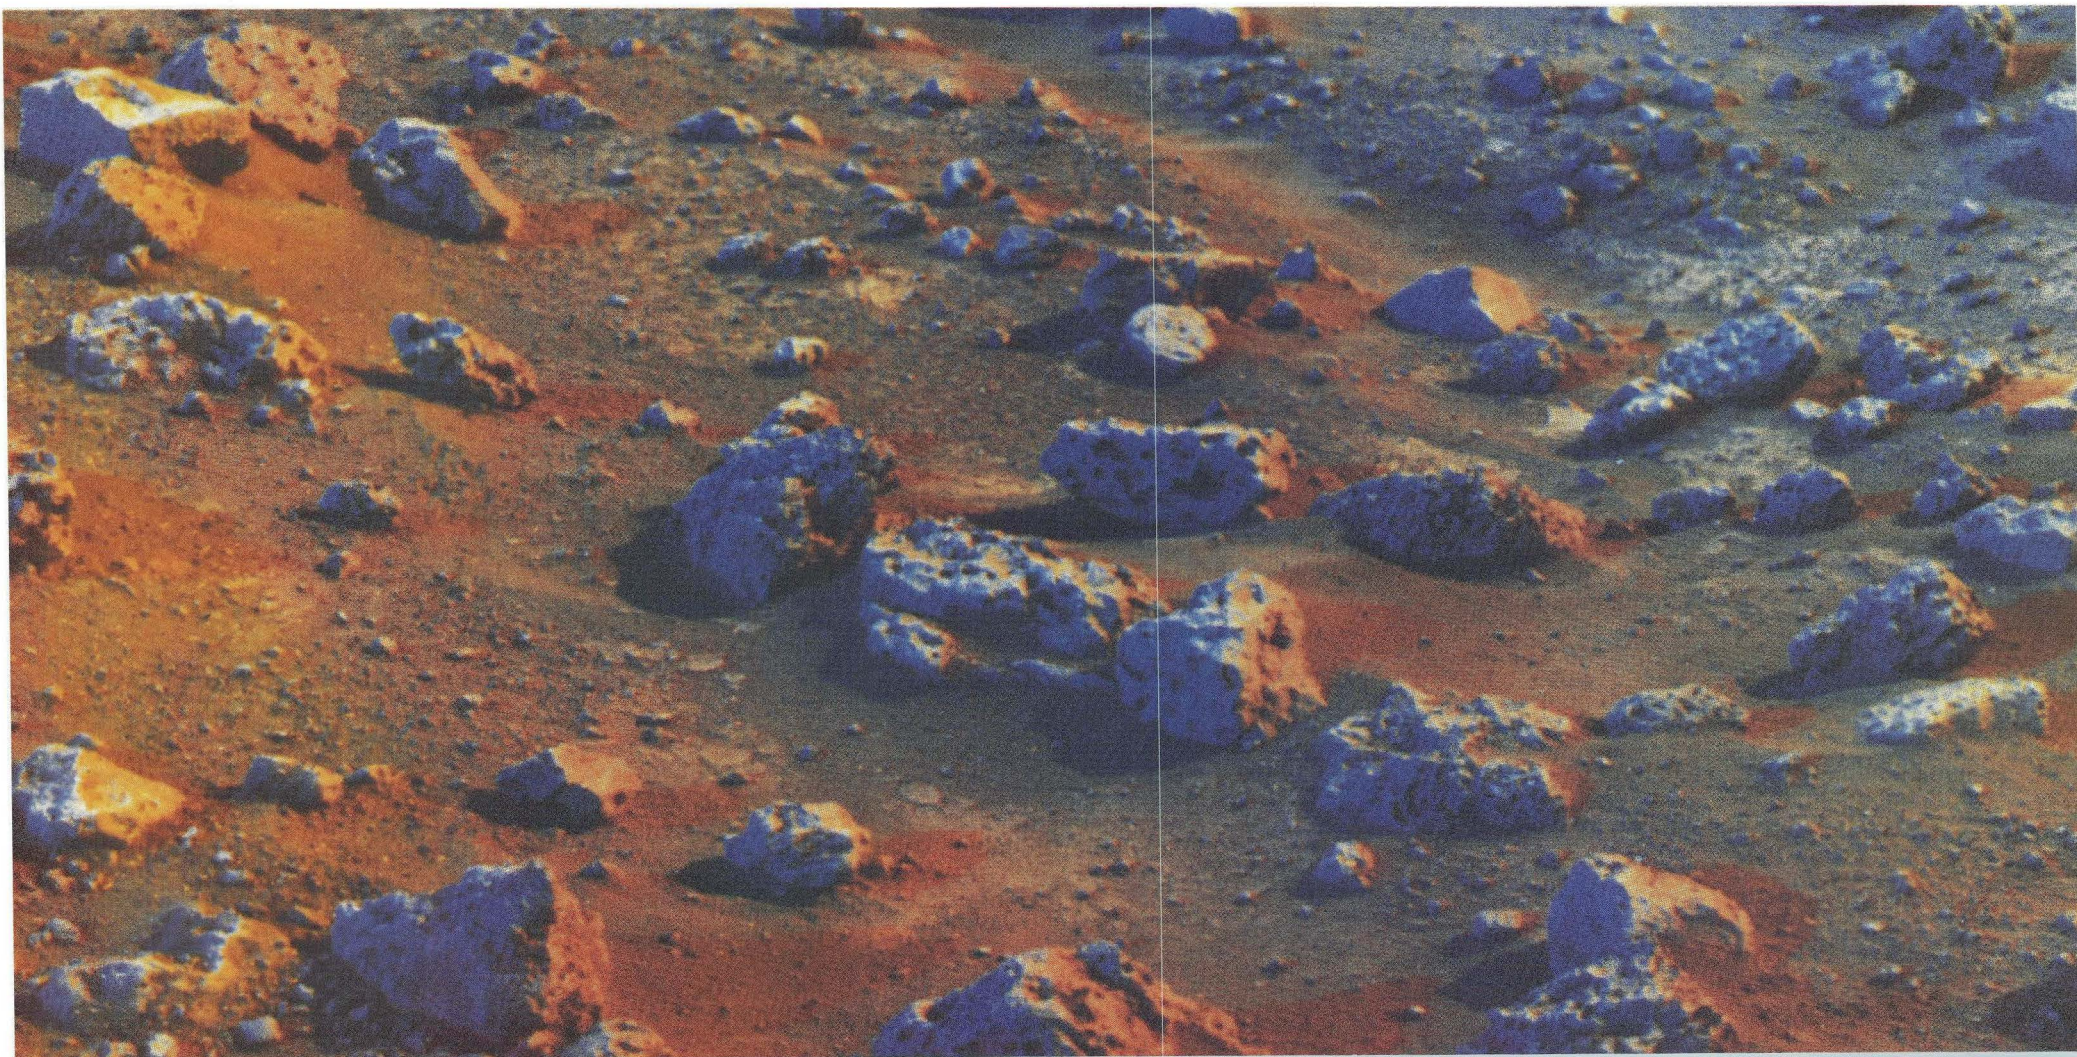
FIGURE 199

Figure 199 can best be assigned to the special effects category. It illustrates one of the many ways in which black-and-white images can be combined and printed in color to yield unusual patterns. In this instance an early morning image is assigned the color yellow and a picture taken in the afternoon is assigned the color blue. Although colors produced in this way are completely false, important details in the scene are sometimes favorably accentuated.

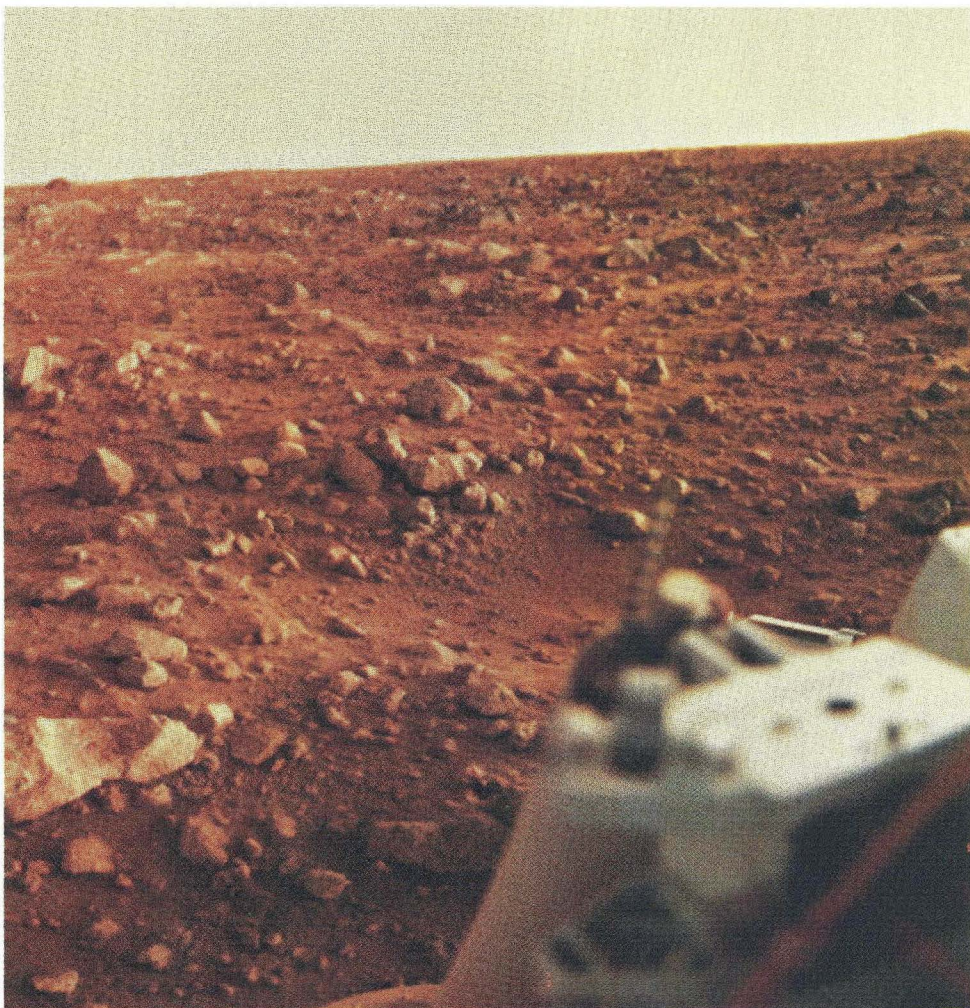
FIGURE 200

Figures 200 and 202 are a related pair, nicknamed the "sundown" and "sunset" pictures. Early in the mission, when it became clear that there was a large amount of scattering particles in the lower atmosphere, we realized the potentially dramatic appeal of low-Sun pictures. However, the first priority was to document the landscape with high-resolution and color images. Following several weeks of successful operation on the martian surface we relaxed to the point of attempting exotic but high-risk

pictures. The sundown picture was taken on sol 30, just 5 min before the sunset picture. The Sun is to the right, only 4° above the horizon. When the sunset picture was taken the Sun was 2° below the local horizon. The banding in the sky is an artifact produced by the camera. The brightness actually changes continuously, moving away from the Sun, but the natural continuum is divided into incremental brightness levels by camera electronics. If the number of quantified brightness levels were much larger, then the closely spaced steps would more closely approximate the continuous gradation of the natural scene. The slightly different color from band to band is also an artifact, caused by the fact that the brightness boundaries for the three color channels are not coincident. The general tendency for the sky to become bluer in the direction of the Sun is real, caused by dominant short-wave-length forward scattering of light in that direction. No planets or stars are visible in the evening sky. The occasional pinpoints of color,

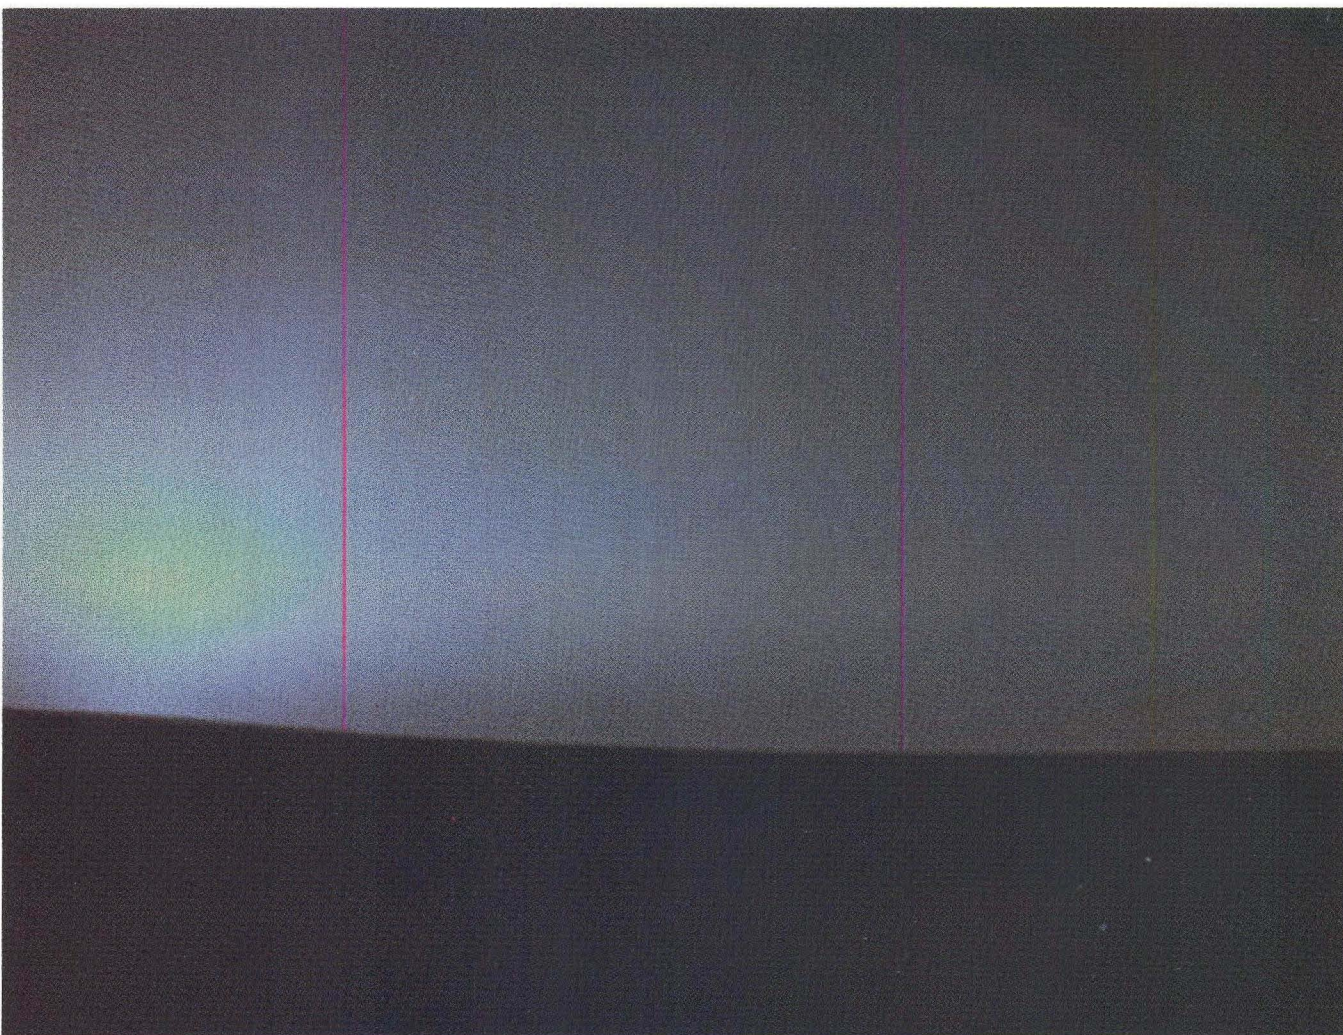
FIGURE 201

Later in the mission the sunset picture was matched with a sunrise picture at the Viking 2 site (fig. 201). Again, the Sun is several degrees below the horizon. The relatively pronounced blue shading in the sky is probably a result of early-morning ice-crystal fog.

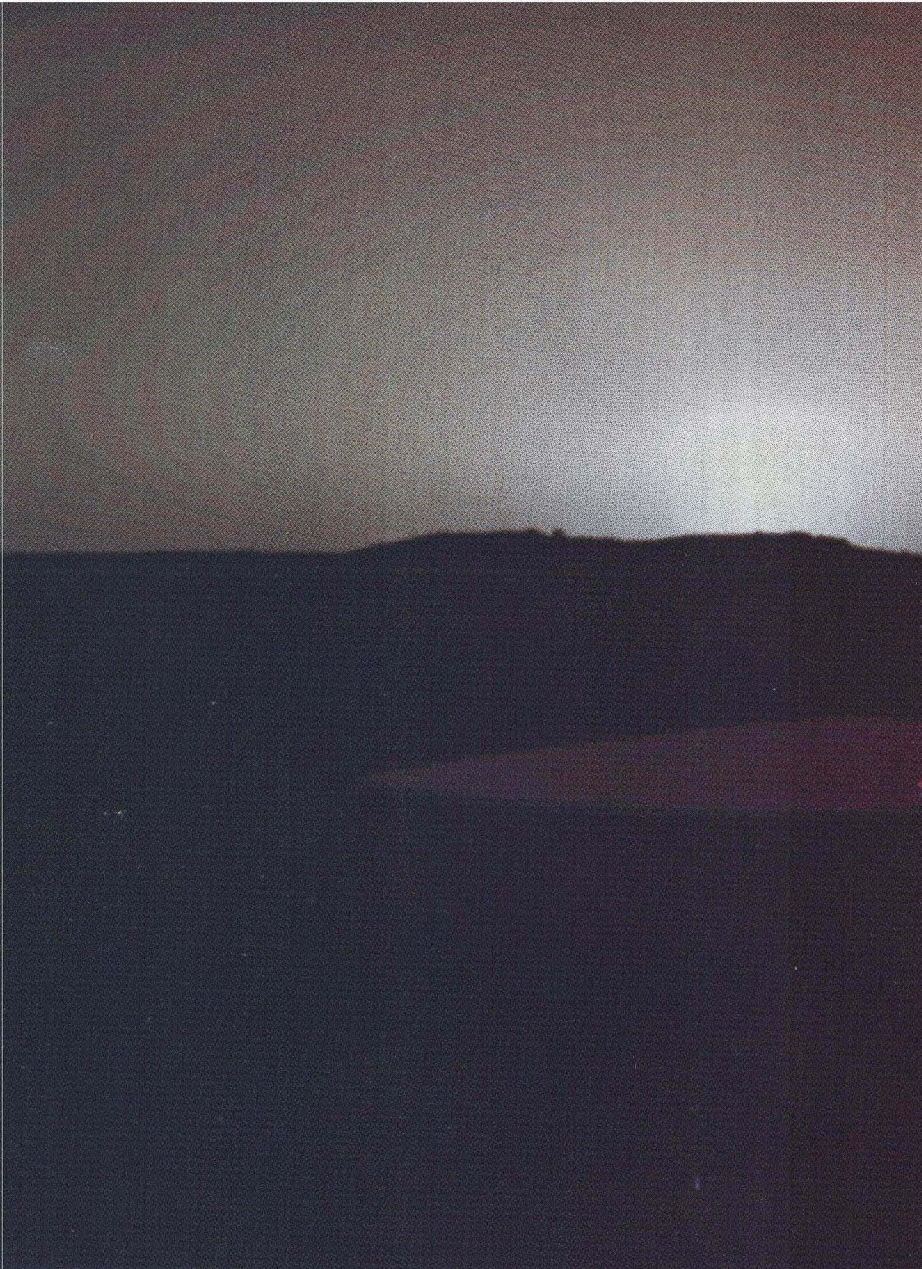
FIGURE 203

especially noticeable in figure 203, are artifacts caused by noise in data transmission and by mismatching during image enhancement.

Initially dismissed as little more than an oddity, the sunset picture has been reproduced many times, especially in its more exotic "stretched" version (fig. 203). Admittedly, this version is more an art object than a scientific product. The colors have been specially enhanced to bring out the detail in the foreground. However, the visual impact of this computer-painted scene is universal: the martian twilight envelopes the viewer.

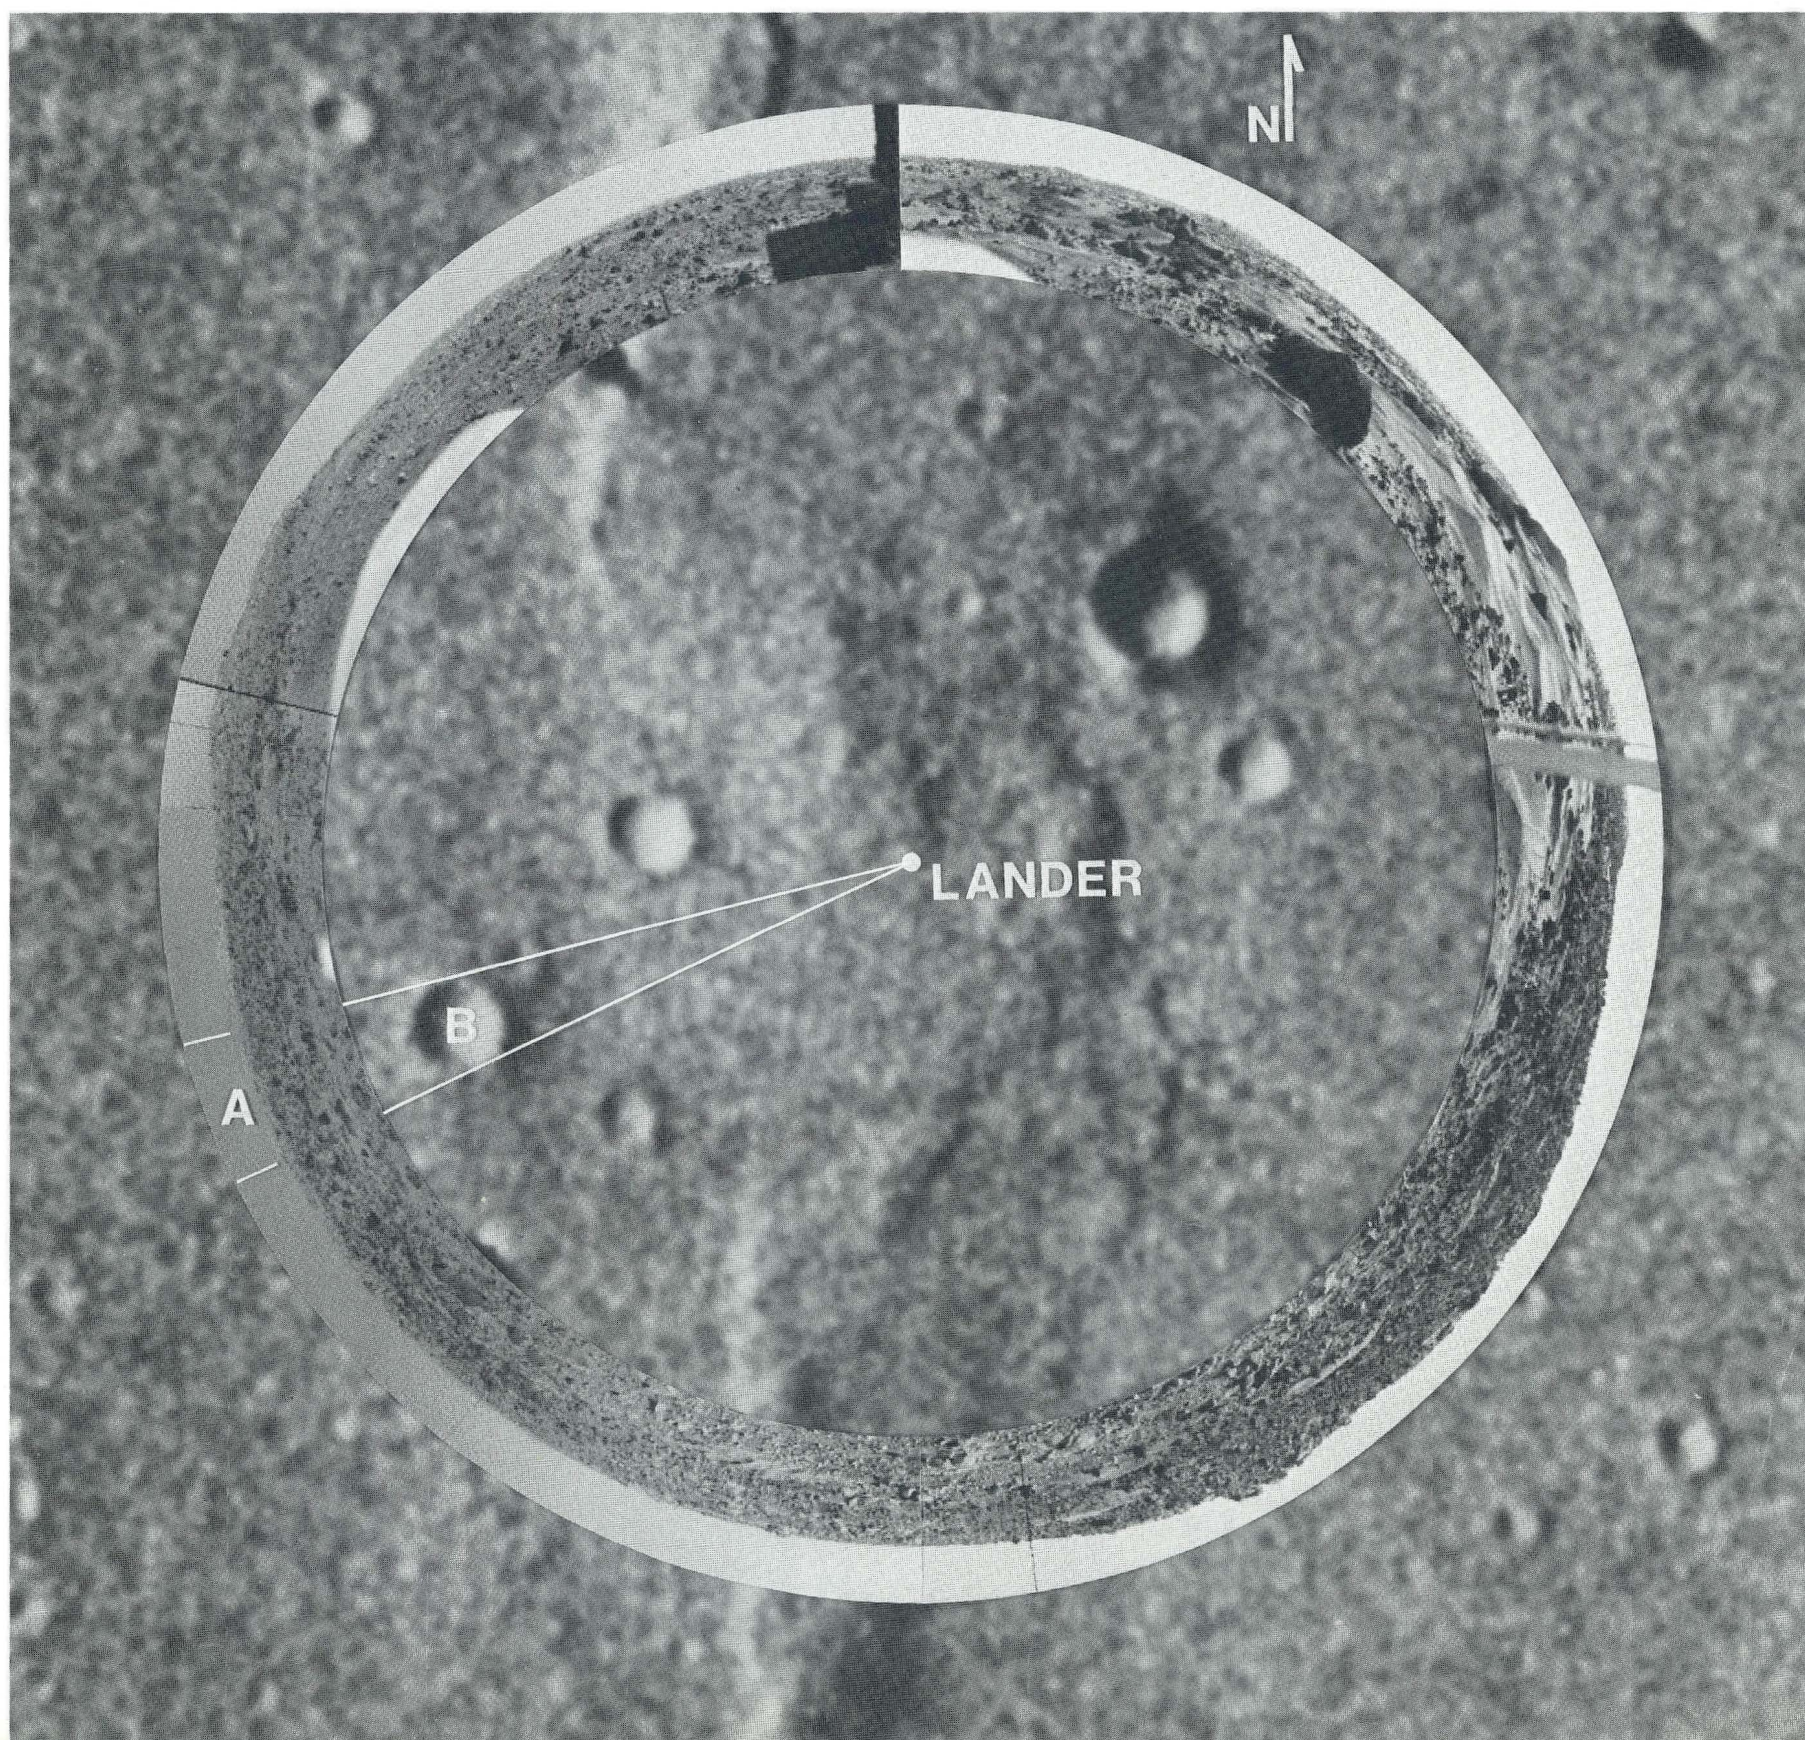
FIGURE 204

Figure 204 illustrates our best estimate

at correlation of Lander and Orbiter pictures. Lander 1 panoramas have been computer-distorted into a circular format, something like the image obtained with the fisheye lens of a conventional film camera. This makes it easier to correlate the image with an Orbiter picture. For example, moving out along a straight line from the center, any feature intersected in the Orbiter picture should

also be intersected in the Lander picture. The crater rim indicated at point A in the Lander picture is probably the same one indicated at point B in the Orbiter picture. (For a better rendition of the crater, see figs. 77, 78, and 79.) Other nearby distinctive features in the Orbiter picture may be masked in Lander pictures by local hills and rises. Incidentally, the landing site viewed from orbit resembles a sparsely cratered lava plain, very similar to the dark lunar maria. This is consistent with the interpretation from Lander pictures but, at this more detailed level, the lavas are seen to be broken up and modified by wind action and by other processes.

This same crater has been identified in Orbiter photographs and has been used to locate the Lander position. Refer to figure 204. Also visible beyond the crater rim is a ridge 8 to 10 km distant.

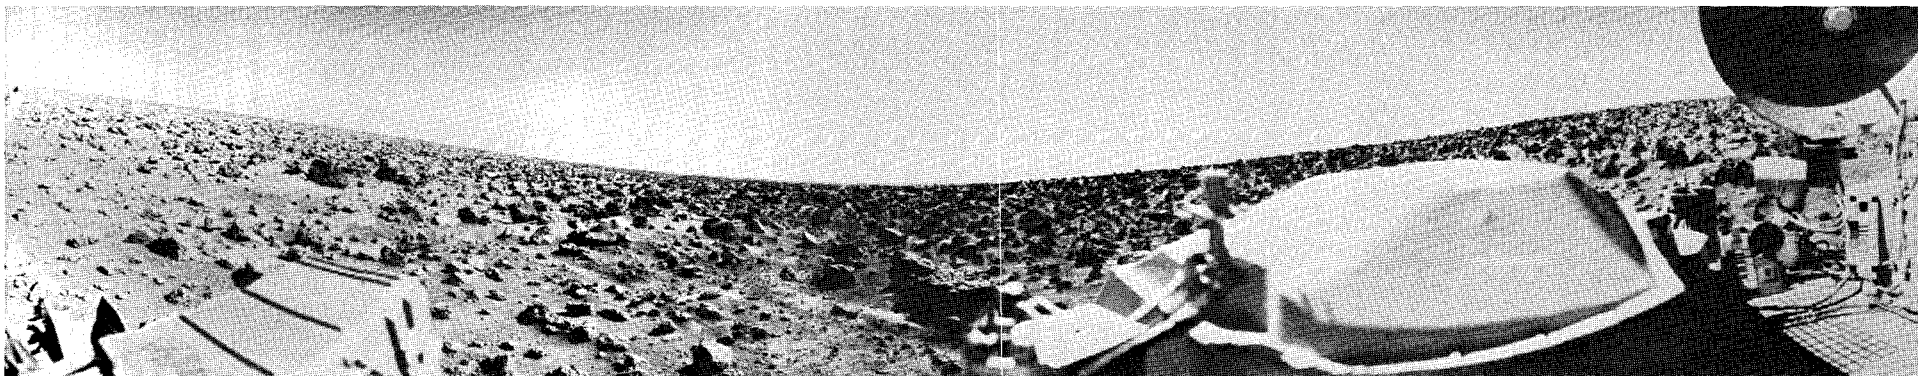
FIGURE 205

Viking 1 landed with a tilt of 3° down toward the west. The tilt of Viking 2 is much more noticeable, 8.5° down toward the west (fig. 205). In both cases the tilt causes the horizon to appear as a gentle, undulating curve over the azimuth range of 360° . When the Lander 2 scene is rectified to the perspective of a vertically oriented camera, it appears as in figure 206. Note that the horizon is now almost perfectly horizontal.

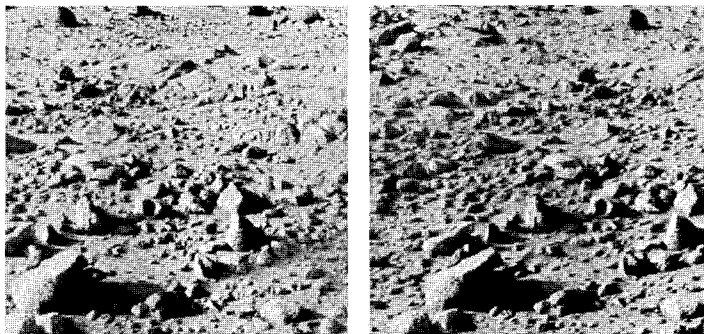
FIGURE 216

For some persons, fusion will not be accompanied immediately by a three-dimensional effect. If you are uncertain regarding your own success, continue to look at the landscape, moving the viewer slightly if necessary. When the third dimension is optimally perceived, a succession of ridges and depressions will be so sharply delineated as to give the impression of a series of discrete vertical planes, moving away from the spacecraft. When you have obtained the appropriate effect for the farfield, work your way back into the nearfield. Once you "lock in," subsequent attempts will be considerably easier. Perhaps the most striking phenomenon to be observed stereoscopically is the undulating character of the scene, particularly at the Viking 1 site. Figures 208 to 215 comprise a panorama in front of the spacecraft, moving in a clockwise direction. Figures 216 and 217 reveal details of rocks in the

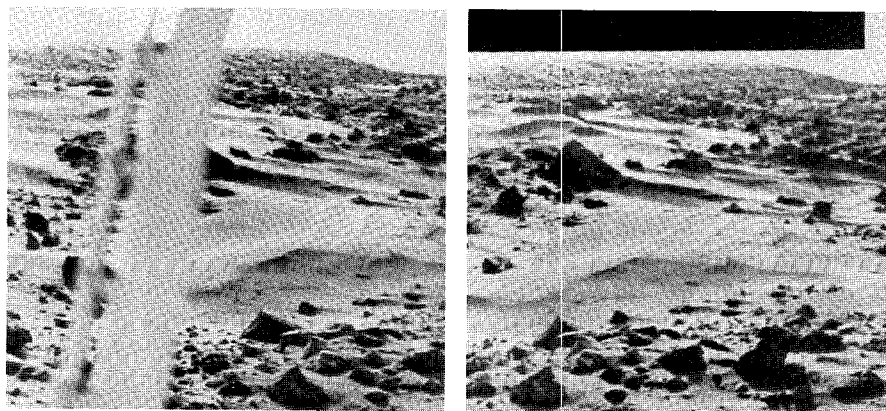
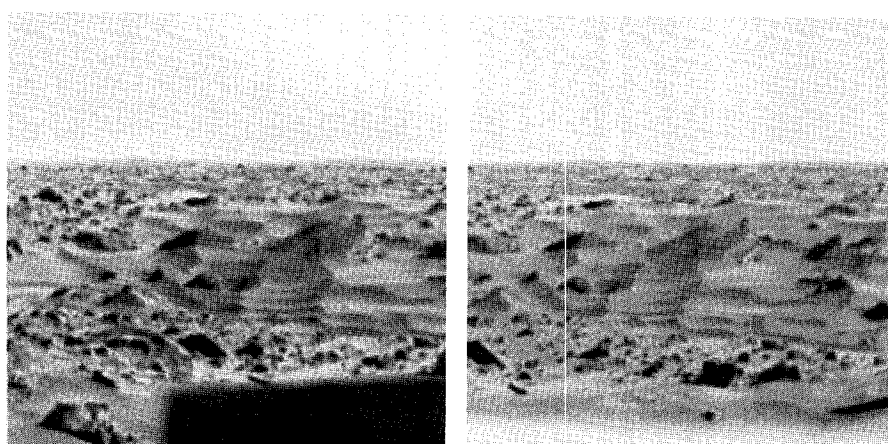
foreground. Figures 218 and 219 show topography in the vicinity of the sediment drifts. Figures 220 to 223 comprise a second panorama looking to the right of the Lander toward the northwest. Drifts of sediment, intermixed with clusters of boulders, occur throughout the scene.

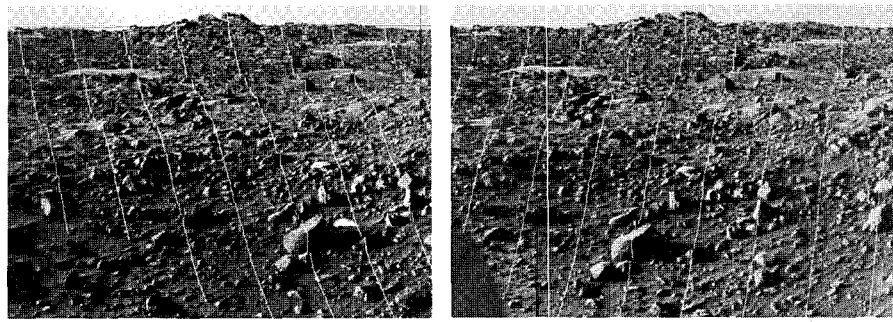
FIGURE 224

Three stereopairs, figures 224 to 226, have superposed on them contour lines generated with the aid of a computer. In one case (fig. 226) the lines are drawn to represent horizontal planes intersecting with the surface, similar to a conventional topographic map. In the other two images (figs. 224 and 225) the planes are vertical so that vertical profiles are superposed. During the mission, this combination of graphic and pictorial data proved a valuable aid in planning movement of the surface sampler arm.

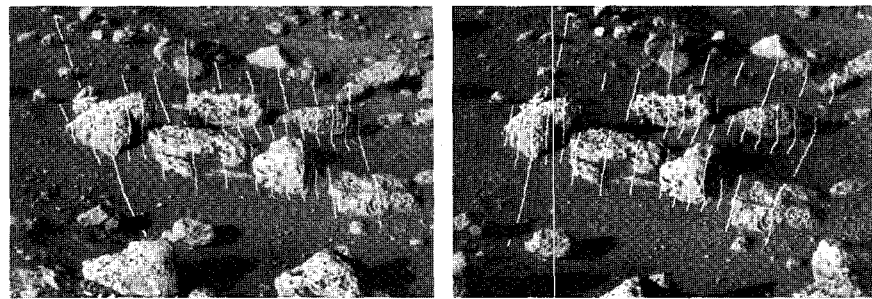
FIGURE 225

The last two figures, 225 and 226, are views of the Lander 2 site. Although there is some relief in the scene, the topographic variations are not as dramatic as at the Viking 1 site.
